# Non-Destructive Testing of the Quality of Wooden Columns in Zeng Jingyi's Ancient Wooden Structures

DOI: 10.15376/biores.20.1.2276-2292

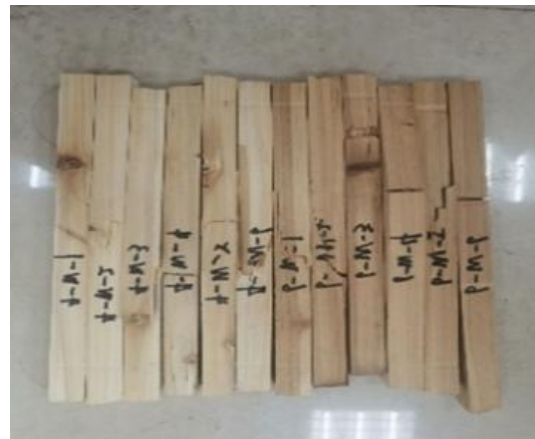
Fig. 6. (a) Four-point flexural test and (b) specimen fracture

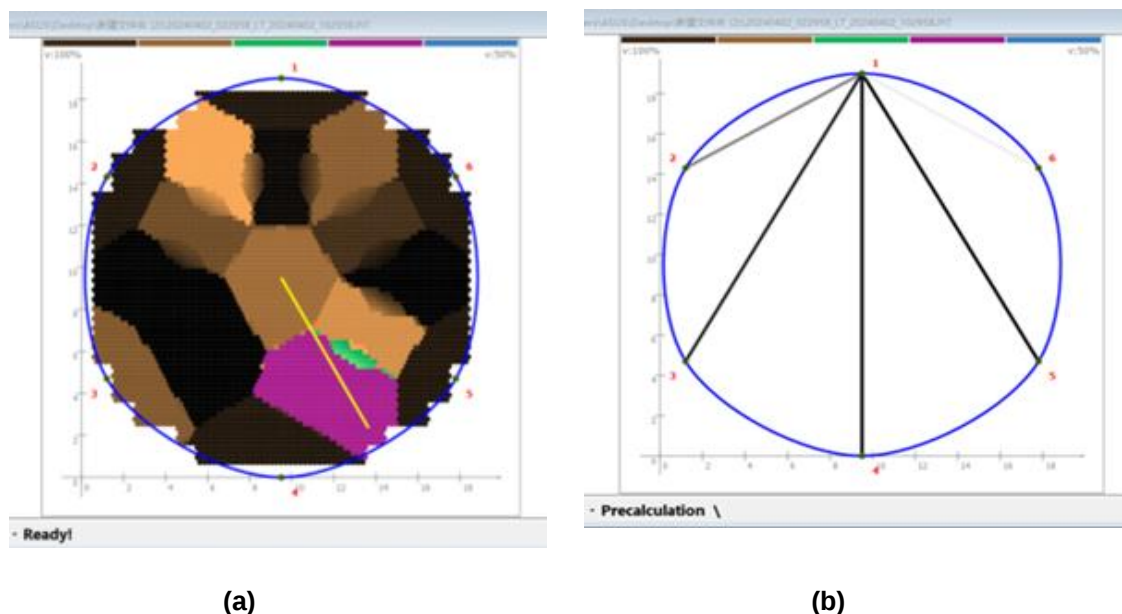
**Fig. 7.** (a) Tomography of section A-1 and (b) signal receiving line diagram of measurement point 1

In Fig. 7, the color of the black line between measuring points 1 and 2 is lighter than that of the other three groups, indicating that the stress wave velocity corresponding to this group of points is lower, that is, the material between the measuring points is poorer.

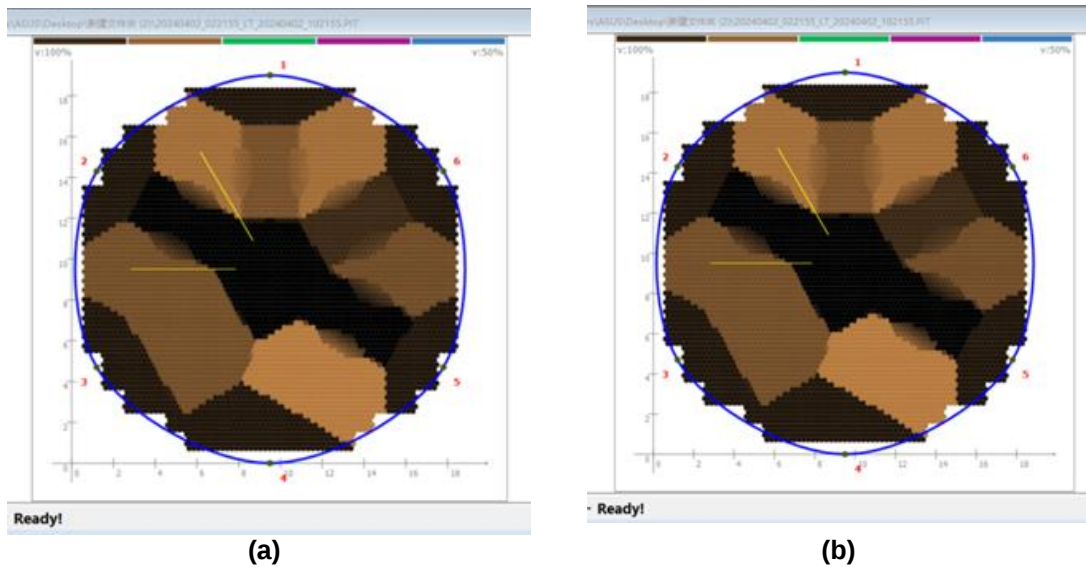
**Fig. 8.** (a) Section A-2 tomograph and (b) section A-3 tomograph

The comparative analysis of the tomographic scan images and the Piro nail test results showed that there were areas with poor material quality at the edges of sections A-3 and B-3, and the Piro nail had the greatest penetration depth in this area. The Piro nail test results were consistent with the tomographic scan images.

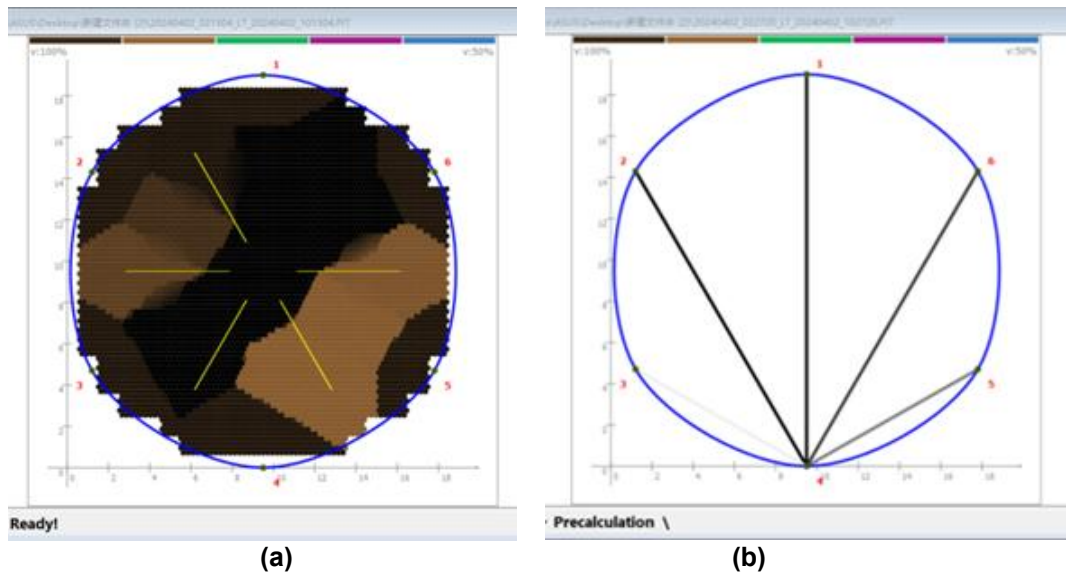
**Fig. 9.** (a) Section B-1 tomograph and (b) signal receiving line diagram of measurement point 4

Figure 9 shows the sensor signal receiving line diagram of measuring point 4 of wooden column B-1. The black line color of measuring points 4 to 5 was lighter than that of the other three groups, which indicates that the stress wave velocity between these points was lower, meaning that the material between the measuring points was poor.

The center of the tomographic image of the wooden column was mainly brown-black, and some edges were purple or green. At the same time, according to the sound velocity distribution table of the test points of the two, each sensor of the six sections of the wooden column showed multiple values with large steep amplitudes, which are represented by red, indicating that the material of the wooden column had obviously deteriorated. At the same time, the maximum stress wave velocity and the minimum stress wave velocity of the wooden column were very different. The mechanical properties of the wooden column had been seriously lost. If it is not repaired, it will be dangerous and not suitable for visiting.
