# Pathological Manifestations in Wood Structures of Amazonian Stilt Houses: A Case Study in Itaituba, PA, Brazil

DOI: 10.15376/biores.21.4.11946-11974

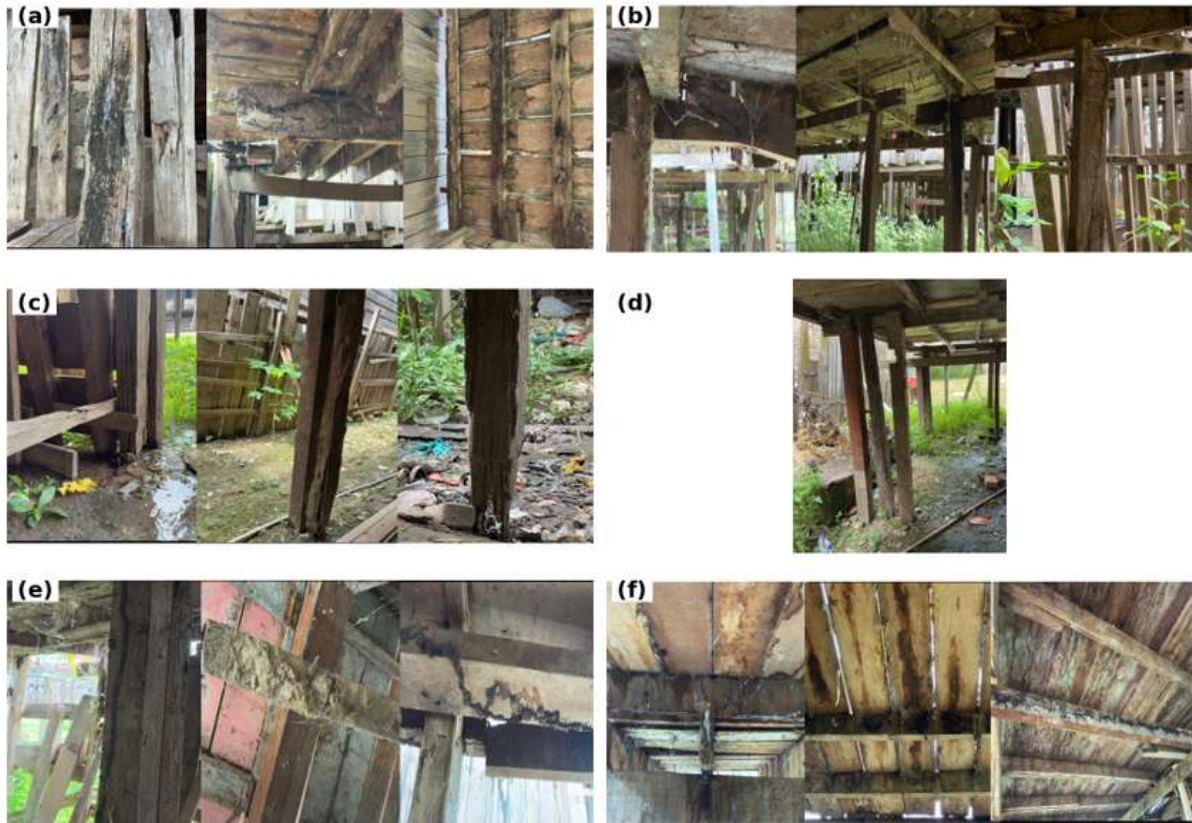
**Fig. 3.** Representative pathological manifestations documented in the evaluated stilt houses: (a) decay fungi in beams and pillars; (b) rupture/displacement in apparent structural elements; (c) degraded, hollow, or partially missing pillar bases and tops; (d) member instability; (e) visible subterranean termite tunnels; and (f) staining/mold fungi. Source: Authors (2026)

Rupture or displacement in apparent structural elements received the maximum GUT score (125), ranking among the most critical manifestations in the evaluated stilt houses (Fig. 3b). Gomes *et al.* (2021) showed that variability in the modulus of elasticity of wood members can lead to larger-than-expected roof displacements, which may contribute to pathological manifestations. In wood structures, overloads may cause excessive deformation or even failure of structural members. Inadequate use, accidental overloads, and lack of maintenance may also aggravate degradation (Brito 2014). Deformations, displacements, and deflections may indicate changes in structural behavior, while instability may manifest itself as buckling of pillars (Brito 2014). Cracks and drying defects may compromise the mechanical resistance of wood members because of internal stresses and fiber discontinuity, affecting structural behavior (Pfeil and Pfeil 2014). In stilt houses, support elements such as pillars and piles are fundamental to the support of the building (Ribeiro 2011; Oliveira Junior 2009). Therefore, fractures and displacements must be monitored, particularly in connection regions, because failures in these zones may compromise safety and, in some situations, contribute to structural collapse (Brito 2014). Similar conditions were described by De Paula *et al.* (2021), who reported that design and dimensional failures, excessive spacing between support beams, and irregular wood elements changed the original roof slope and caused cracks along the fibers at member joints.

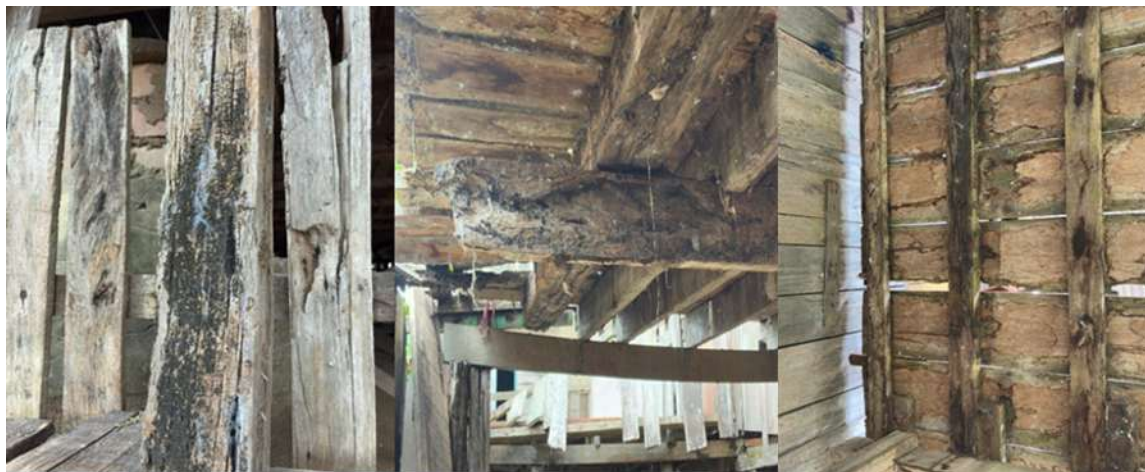
The occurrence of decay fungi in beams and pillars received the maximum GUT Matrix score (125), reflecting the high criticality of this pathological manifestation in the stilt-house structures. Zeni *et al.* (2005) experimentally documented wood degradation caused by white-rot fungi. In buildings, persistent moisture and water infiltration can favor decay and compromise the integrity and mechanical resistance of wood structural members (Brito 2014; Martins and Fioriti 2016).

**Fig. A1.** Occurrence 1. Decay fungi in beams and pillars. GUT score: 125

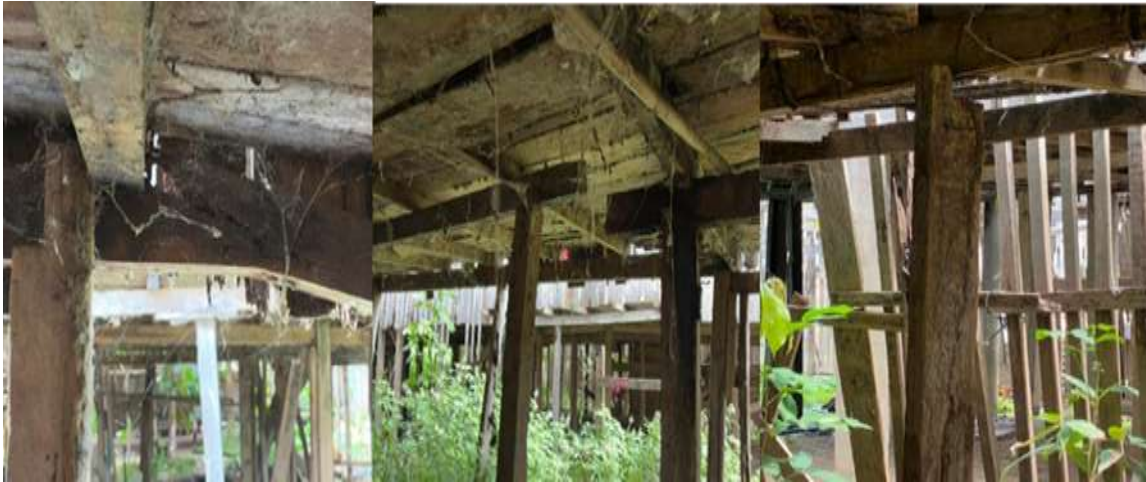
The displacement and misalignment observed in the case-study structures should not be interpreted as evidence of a single biological mechanism. Visual inspection alone cannot distinguish among loss of support caused by member deterioration, connection irregularities, geometric defects, or movement/settlement at the pillar base in saturated soil. Accordingly, settlement in soft floodplain soil is a plausible mechanism, but it was not measured and cannot be confirmed from the present data. The manifestation was therefore treated as a structural condition requiring technical inspection rather than being attributed exclusively to biodeterioration. Parra *et al.* (2022) documented an analogous loss of contact between a beam and its supporting pillar, in which geometric irregularities and loading contributed to instability and required emergency shoring.

**Fig. A2.** Occurrence 2. Rupture/displacement in apparent structural elements. GUT score: 125

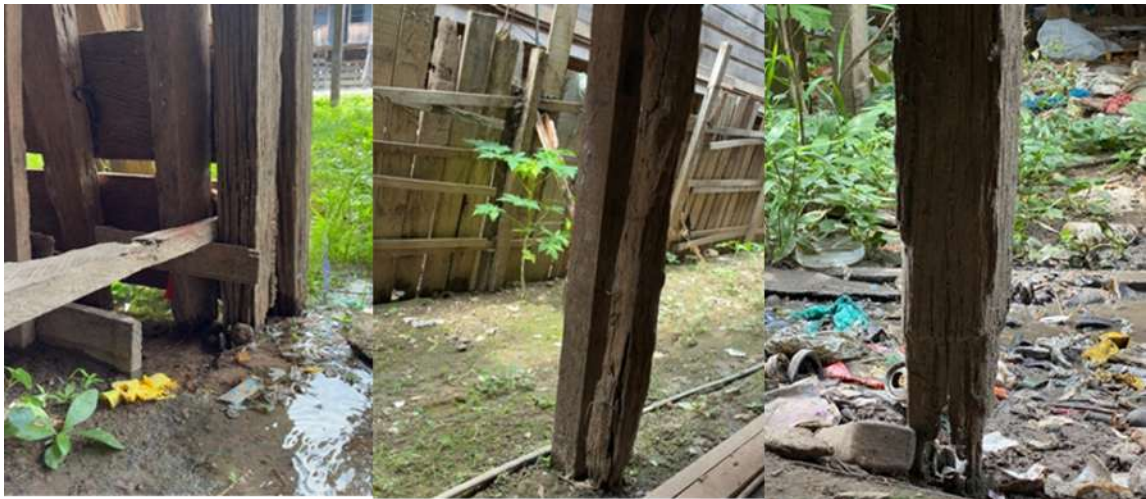
Degraded or hollow pillar bases received the maximum GUT score (125), which confirms their high criticality. Pillar ends are particularly vulnerable when they remain

The occurrence of deterioration at both pillar bases and tops indicates that the moisture source is not necessarily limited to floodwater or water beneath the house. Lower ends are compatible with exposure to saturated soil, floodwater, and retained moisture, whereas deterioration at upper ends may also result from rainwater, roof leakage, splash, or local water accumulation at connections, as reported for other timber structures (Martins and Fioriti 2016; Parra *et al.* 2022). The field observations therefore support rainwater as a plausible contributing mechanism, particularly at upper ends; however, the study did not measure moisture sources separately and cannot quantify their relative contributions.

**Fig. A3.** Occurrence 3. Degraded, hollow, or partially missing pillar bases and tops. GUT score: 125

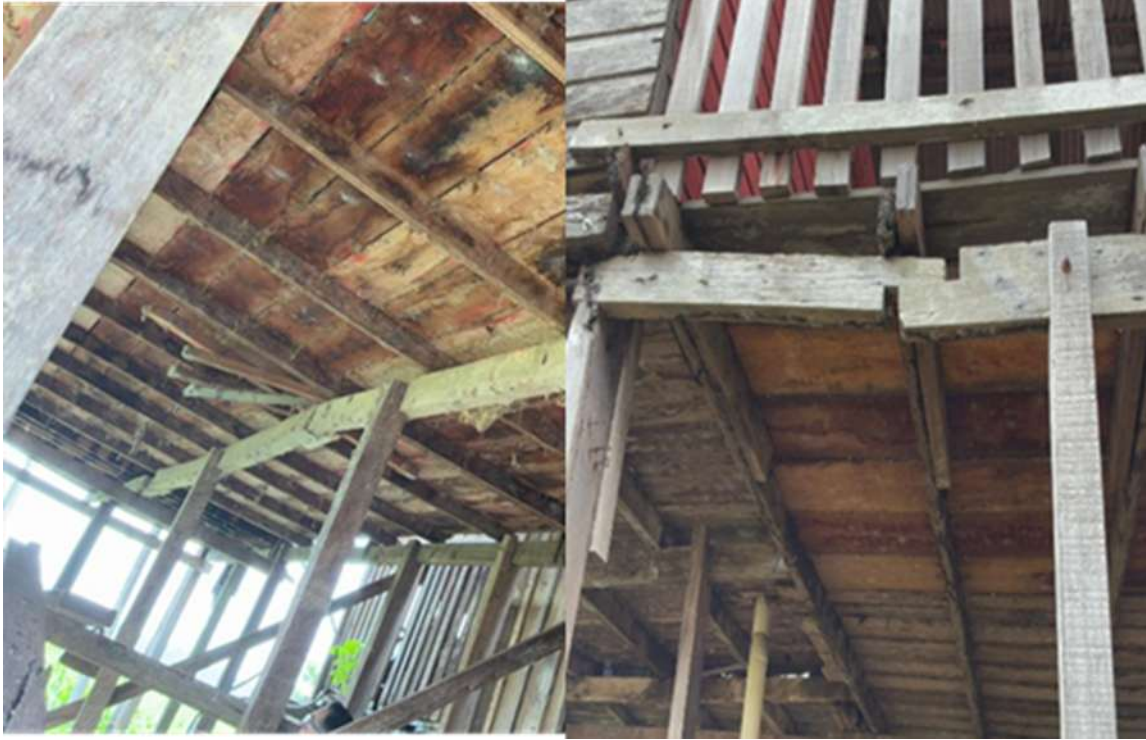
Visible deformation in stilt-house beams received the maximum GUT score (125), classifying it as a high-severity pathology. This condition results from the combination of applied loads and creep, which, according to Silva (1989), is characterized by the progressive increase in deformation over time under constant loading.

**Fig. A4.** Occurrence 4. Visible deformation in beams and pillars. GUT score: 125

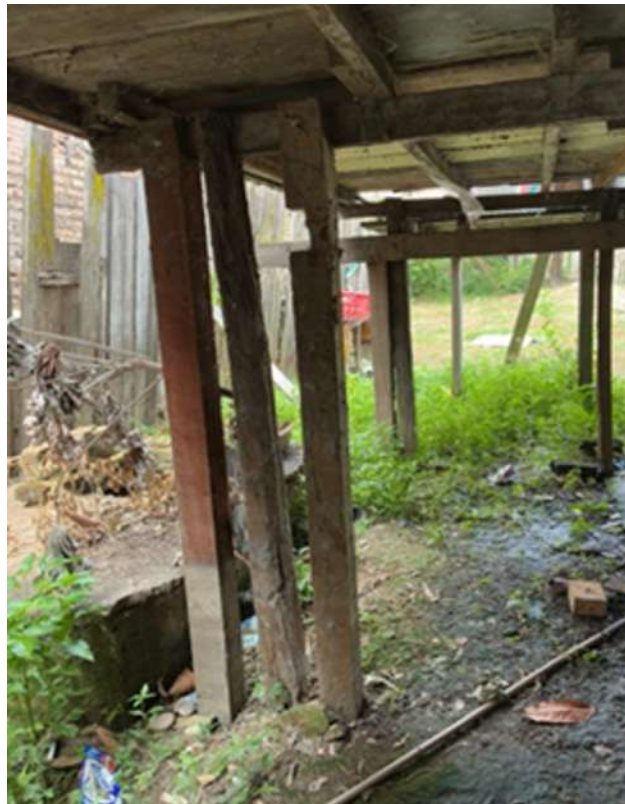
Member instability also received the maximum GUT score (125), confirming its criticality in stilt houses. Instability results from loss of structural integrity, changes in support conditions, and progressive deterioration of resistant elements, all of which compromise global equilibrium (Brito 2014). In the observed cases, this condition was evidenced by pillar misalignment, visible inclination, and apparent loss of plumb, indicating that the structure no longer maintained its original stable position.

**Fig. A5.** Occurrence 5. Member instability. GUT score: 125

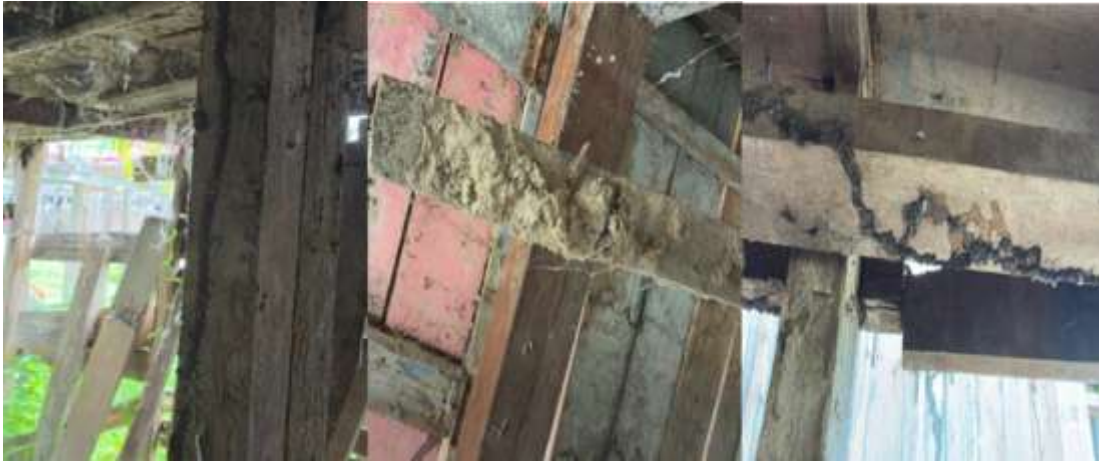
**Fig. A6.** Occurrence 6. Visible subterranean termite tunnels. GUT score: 80

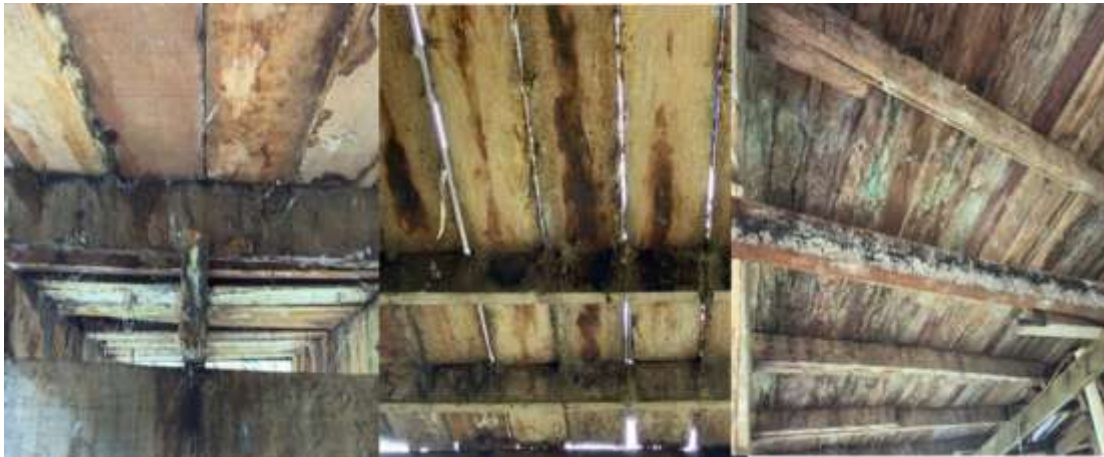
**Fig. A7.** Occurrence 7. Staining/mold fungi. GUT score: 80

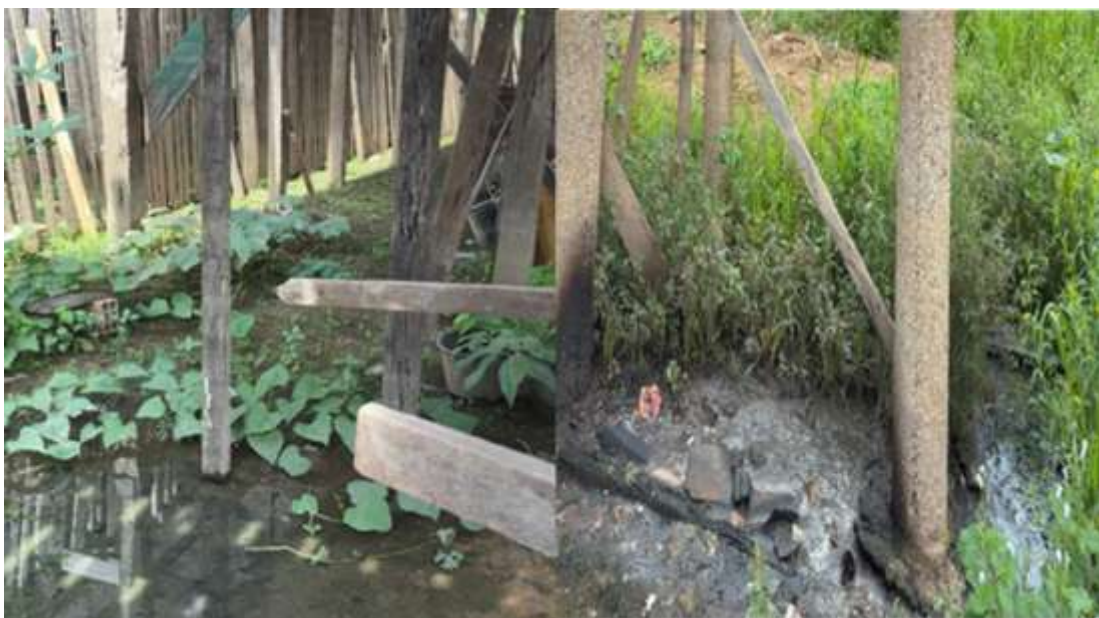
**Fig. A8.** Occurrence 8. Deterioration due to excessive moisture. GUT score: 80

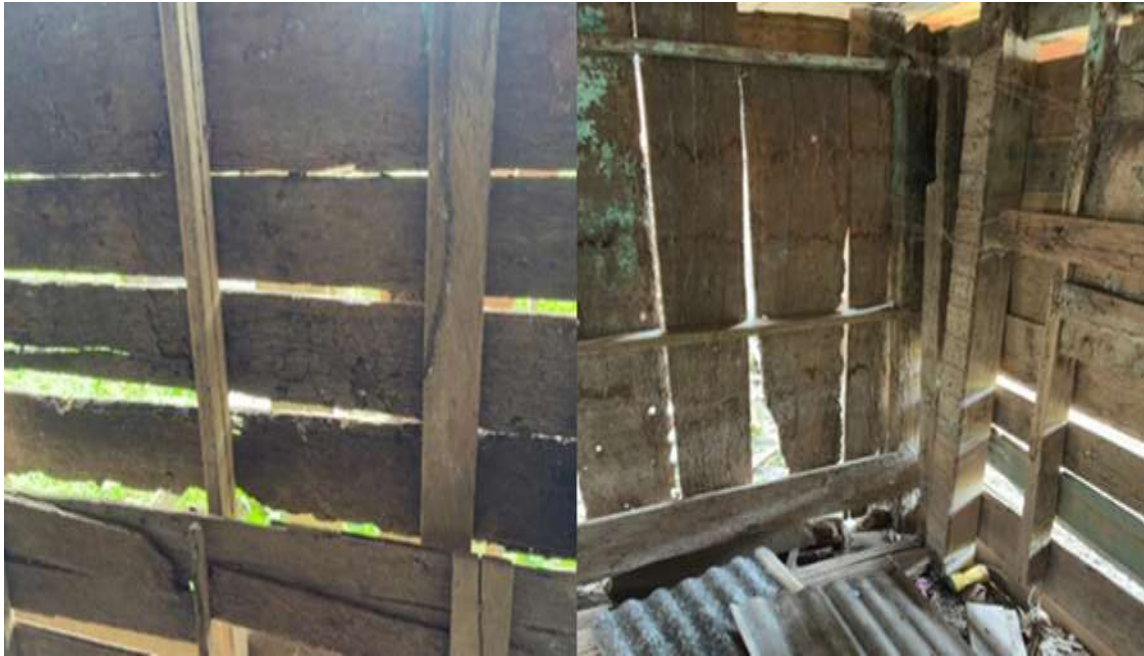
**Fig. A9.** Occurrence 9. Guardrails/enclosures with decay at the base. GUT score: 64

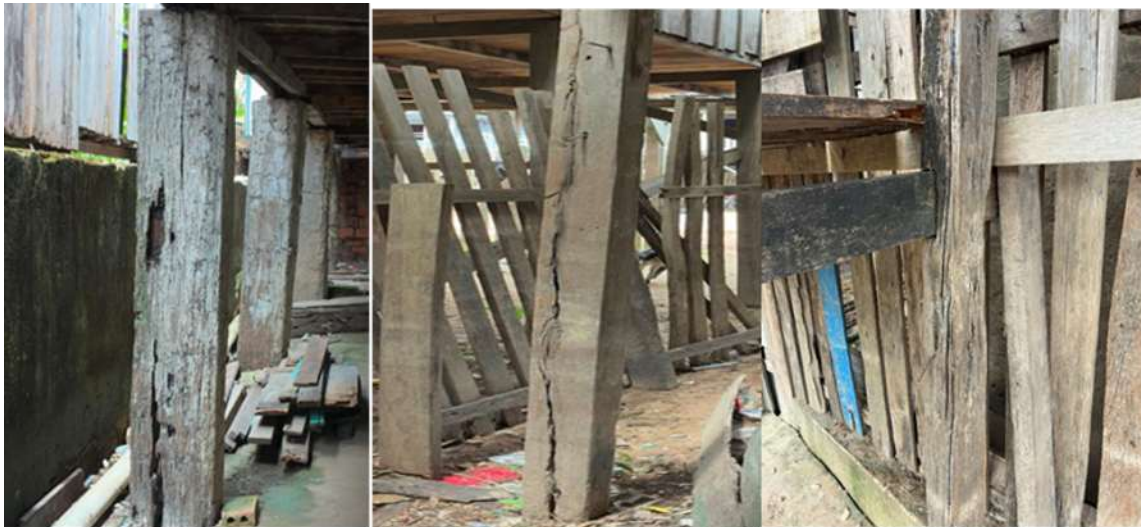
**Fig. A10.** Occurrence 10. Deep longitudinal cracks in pillars. GUT score: 36

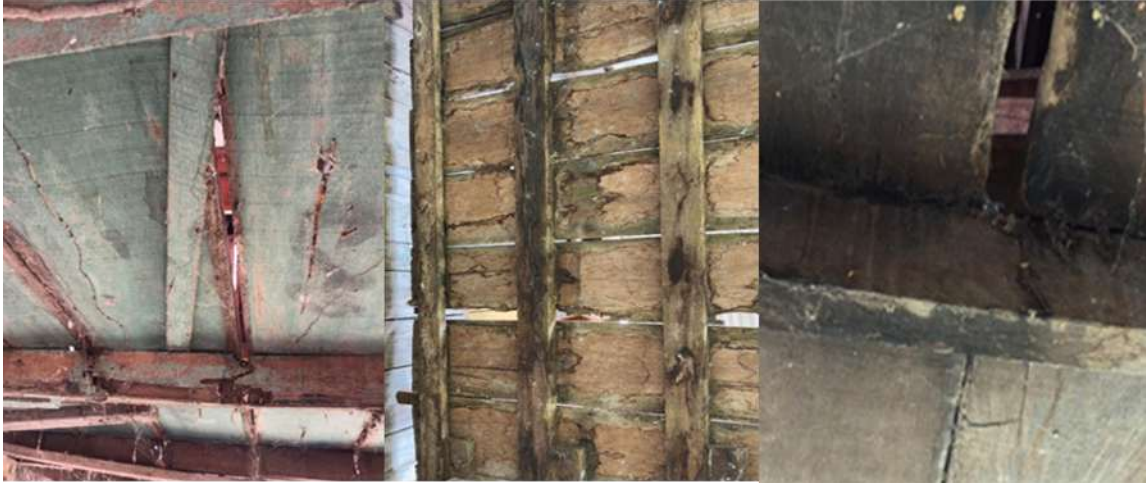
**Fig. A11.** Occurrence 11. Floor gaps larger than 5 mm. GUT score: 27
