# Pathological Manifestations in Wood Structures of Amazonian Stilt Houses: A Case Study in Itaituba, PA, Brazil

DOI: 10.15376/biores.21.4.11946-11974

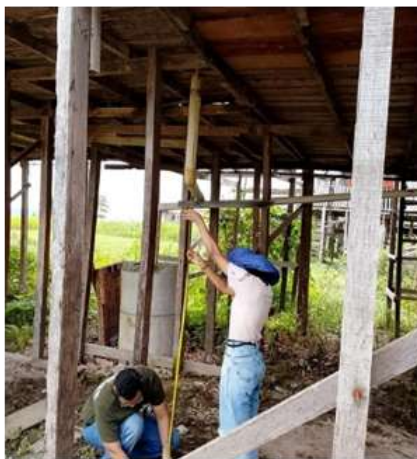
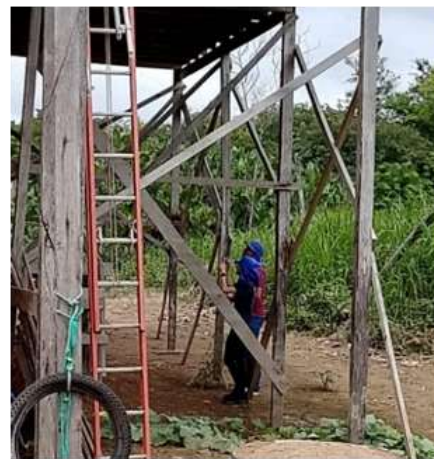
**Fig. 2.** Assessment in stilt house sample: (a) visual inspection of lower elements and (b) altimetric measurement. Source: Authors (2026)
