# Properties of Wood Shear Walls Connected by Wood Nails

The performance of a wood wall connected by wood nails and twist nails was tested. It was found that during the monotonic load testing, the wood nails connected to the shear panel and stud at the column bottom broke when the deformation reached 12.1 mm. However, the primary failure mode was that the twist nails bent and the head cap became dented in the shear panel. For reciprocating loads, it was found that the wood nails experienced local fracture on the tensile side. The skeleton curve of the wood wall connected by twist nails showed a good trend of bearing capacity changes in both tension and compression sides. Based on the properties of the standard wood wall, a new T-shaped fastener was designed for the midply wood wall. The lateral performance of the reinforced standard wood shear wall and midply wood shear wall were tested. By adding T-shaped pull-up fasteners, sandwich wall structure and double row nails, the strength, stiffness, and ductility of the midply wood wall were substantially better than those of standard walls connected with twist nails using conventional pull-up fasteners.

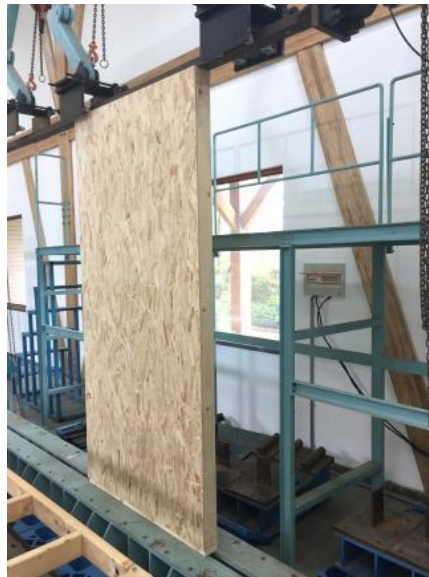
**Fig. 5.** The shear wall fixed to the testing system

The shear wall testing system (YAW-100J; Jinan Popwil, Jinan, China) was used to test all the shear wall specimens according to the national standard China GB/T 37745 (2019). The shear wall fixed to the testing system is shown in Fig. 5.

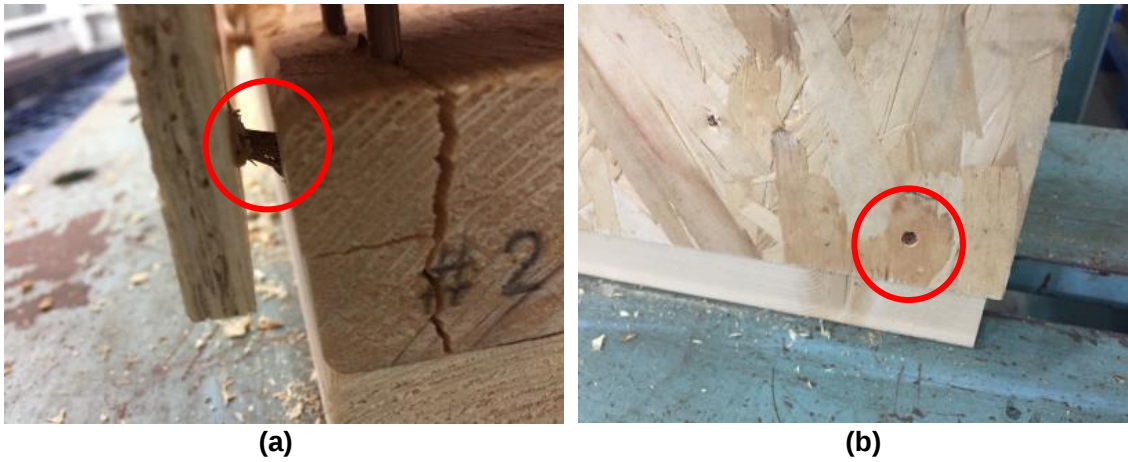
**Fig. 6.** The bent (a) and indentation (b) of the wood nails

Through observation of the experimental phenomenon, it can be seen from Fig. 6(a) that the wooden nails were bent and broken at the base of the wall stud, indicating poor ductility and easy breakage of the wooden nails. Figure 6(b) shows the indentation of the wooden nails on the cover panel. Due to the lack of nail caps for protection, the indentation of the wooden nails was more obvious, and some were even completely separated from the cover panel. Figure 7 shows the pull-out of the composite studs, and the fibers of SPF were pulled out on the surface of the wood nail, indicating that the wooden nail not only had compression effect but also partial welding effect during the insertion process. As the reciprocating horizontal lateral force increased, the wall performed noticeable deformation, as shown in Fig. 8. The wooden nails at the edge of the wall were basically completely broken under the reciprocating force, with the covering panel and studs detached. The wall studs connected by wood nails showed no obvious damage throughout the whole testing process. In contrast, as a comparison, the studs were also separated from the bottom beam in the wall connected by twist nails, as shown in Fig. 9 (Farshid *et al.* 2023). However, when the wall deformation was large, the stud was separated from the bottom beam, the twist nails on the shear panel were bent, and the head caps of the twist nails were partially concave, but still partially connected with the bottom beam (as shown in Fig. 10).

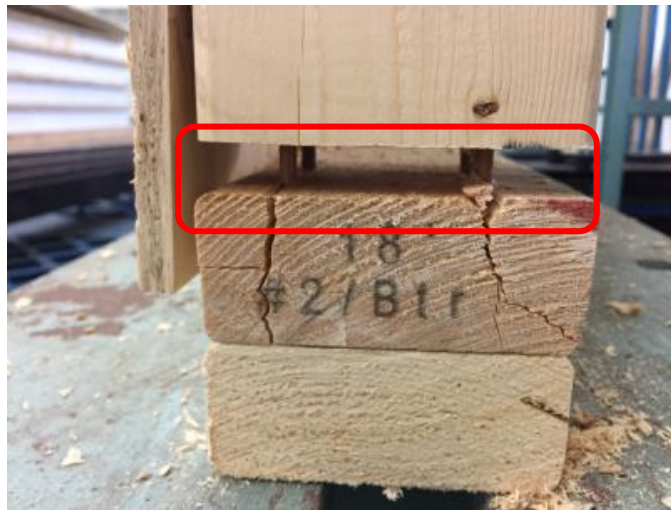
**Fig. 7.** The pull out of the studs

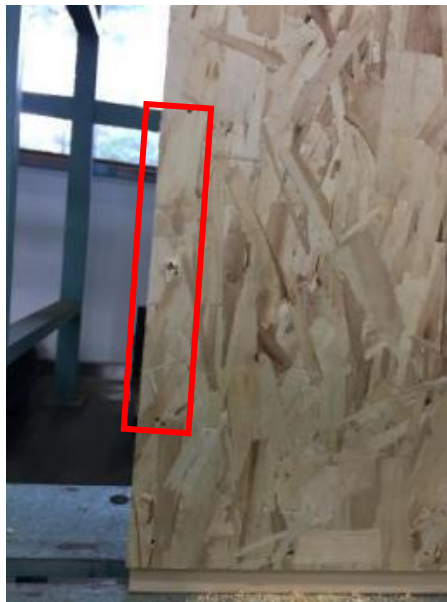
**Fig. 8.** The wood nails fractured and the shear panel separated from the stud

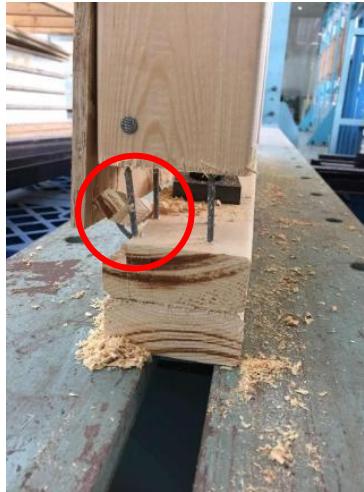
**Fig. 9.** The studs separated from the bottom beam of the shear wall connected by twist nails

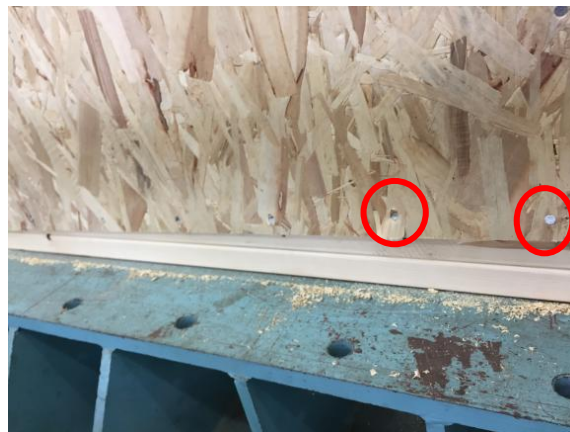
**Fig. 10.** The head caps of the twist nails dented in the shear wall connected by twist nails

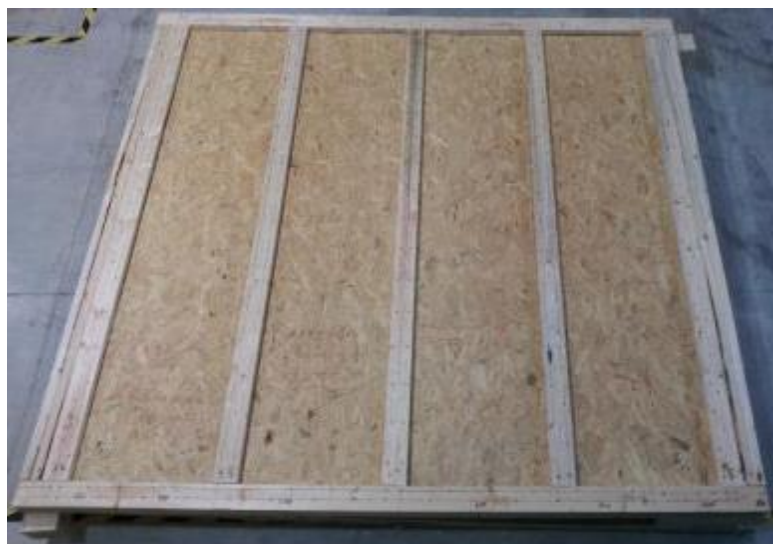
**Fig. 14.** The midply shear wall connected by wood nails

The lateral resistance performance of the strengthened midply wood wall connected by wood nails (Fig. 14) and the standard wall strengthened with conventional pull-up fasteners connected by twist nails were compared in the same size of 2400 mm × 2400 mm. In Fig. 15, the maximum monotonic loading force of the wood wall connected by twist nails was 13.5 kN, and the stiffness at the elastic stage was 695 MPa. The maximum monotonic loading force of the wood wall connected by wood nails was 19.0 kN, and the stiffness in the elastic stage was 1030 MPa, which were higher than the properties presented by Zhang *et al.* (2023). During all the testing process, no obvious damage occurred in the bottom of the column. At last, the break was found in the shear panel connected to the studs by wood nails.
